Service-Information Motorcycle

Group: 23
Gear Box

June 1986
23 008 86
(2217)

Changes in 5-Speed Gear Box -- Boxer Models

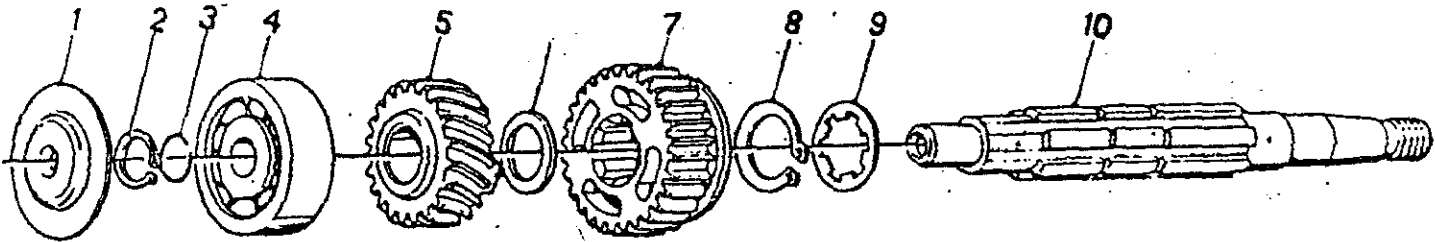
The gear box output shaft no longer has the circlip groove machined into it. Through the use of a new style bearing, the circlip [2] and spacer [3] are no longer needed.

The ball bearing [4] inner race has changed in shape.

Note: It is acceptable to use this new style bearing on older output shafts and not use the circlip and spacer.
