Service-Information Motorcycle

April, 1988
61 016 88
(2301)

Accessory Socket Fuse - R100RS and R100RT Models

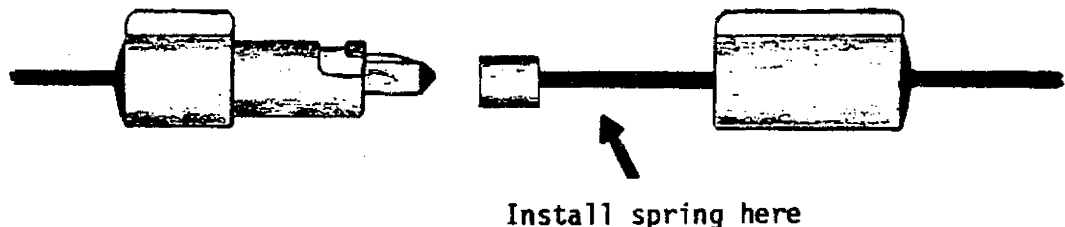
Problem: No electrical current (12 volts) at the accessory socket (BMW Battery Charger does not charge through the socket).

The fuse holder on **some** models was assembled incorrectly. The small spring which tensions the lug into the fuse was installed on the wrong side of the wire lug. This restricts the flow of current through the fuse holder assembly by making a poor contact to the fuse.

Remedy: Remove the fuse spring from the plastic holder. Pull on the wire end lug slightly, exposing 1 inch of the wire. Wind the small spring onto the wire between the wire end and plastic holder. Wind the spring in a manner similar to winding a key onto a key ring, or use a soldering iron to unsolder the lug. Position the spring over the wire and solder the lug on again.
