# Service-Information Motorcycle

August, 1992  
61 027 92  
(2548)

## Additional Ground Between Engine and Frame - R100R Models

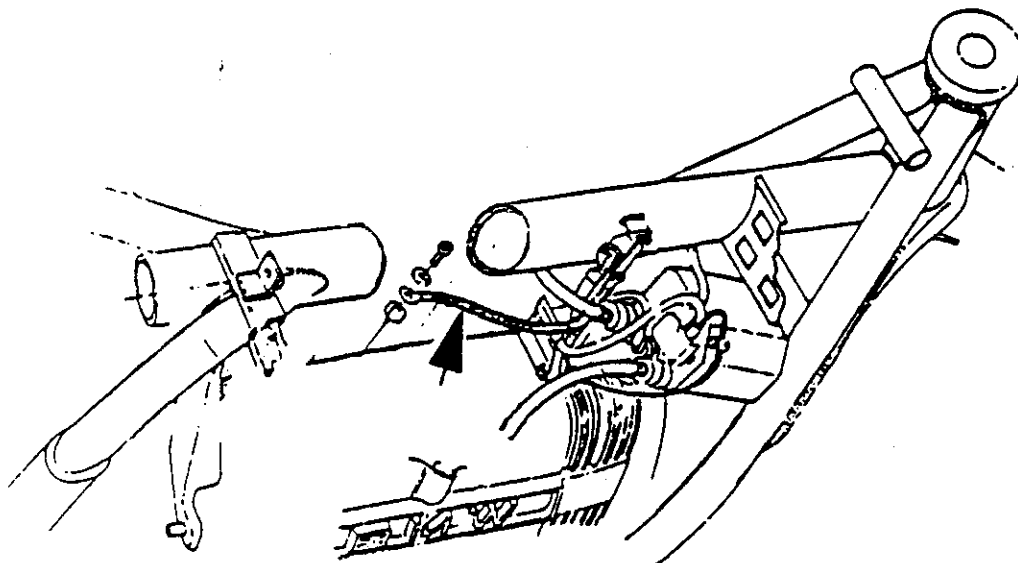
**Problem:** Grounding between the engine and frame is not always reliable on silver-painted frames. This may lead to ignition misfiring or insufficient alternator output.

**Remedy:** Install a ground wire to all affected R100R models with a VIN prior to 0280227.

The ground wire is secured to the left starter motor cover screw and the ignition control unit mounting bracket.
