Service-Information

Group 13 Fuel Supply & Adjustment	May 1980	Bulletin No.: 13 003 80(2021)
--------------------------------------	-------------	----------------------------------

Subject: Air Intake Modification for all 1980 Models

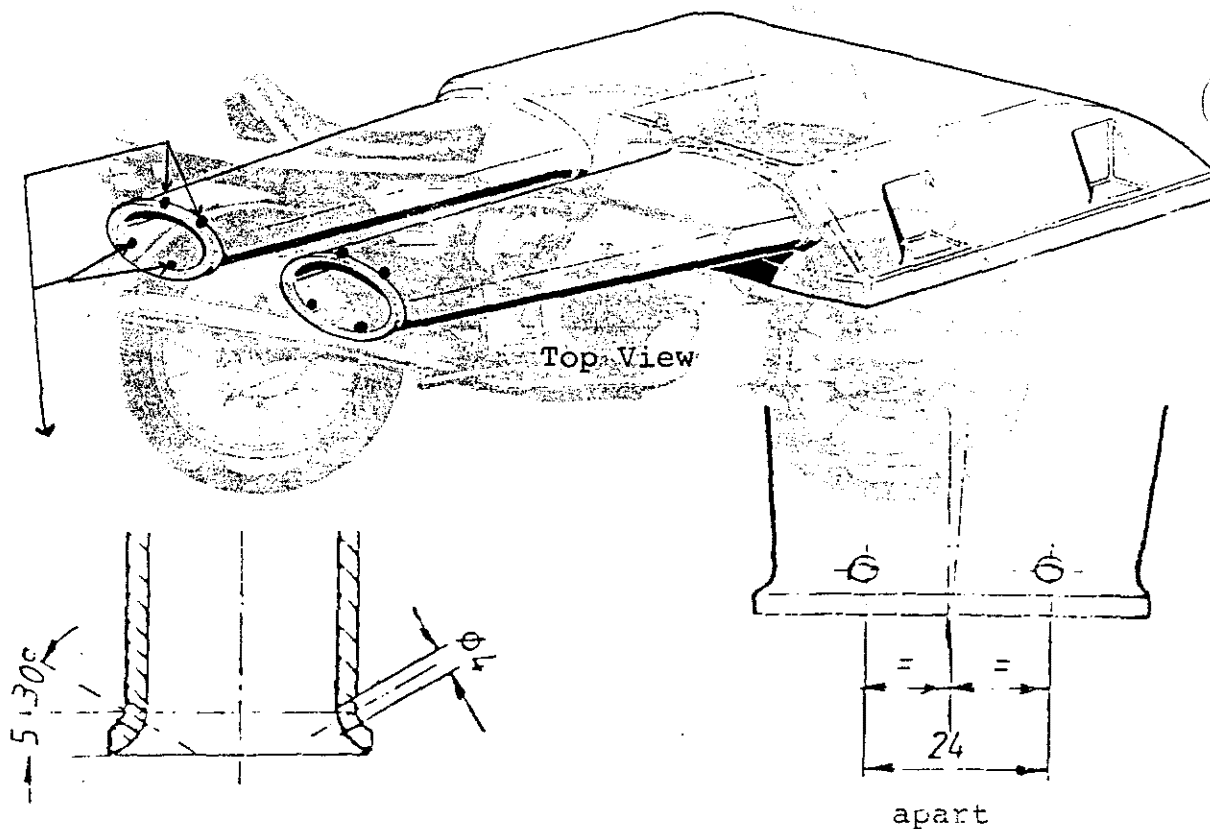
Subsequent to the start of 1980 model production, it was discovered that a modification to the air filter housing top was beneficial to the air intake/carburetion systems.

Motorcycles lacking this modification may experience a mid-range flat-spot in the carburetion as the restricted air intake creates an overly rich condition in the combustion chamber.

The modification consists of drilling four (4) holes in each air horn as indicated in the drawing below.

at a 30° angle
5 mm from the edge
