Service-Information Motorcycle

Group: 13
Fuel Supply
& Adjustment

August 1990
13 020 90
(2414)

Carburetor Vibration - 1988 R100

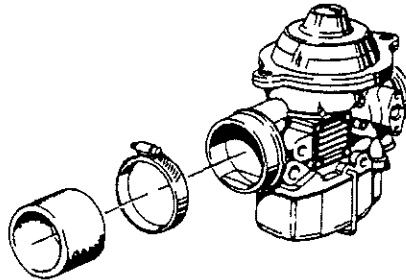
Complaint: Presence of fuel stains on the outside of the carburetor and float bowl. This could occur when engine is running at certain higher rpm's.

Problem: The carburetor can vibrate at certain speeds (usually high-speed), causing an increase in the fuel level in the float bowl.

Remedy: First, ensure that float bowl gasket is in good condition, that no contaminants are present in float bowl, and that fuel level is to specification. If the items mentioned above are all correct, then install carburetor mounting rubber tubes #13 72 1 254 654 in place of the stock tubes #13 72 1 338 360. These tubes have a different rubber density which will reduce carburetor vibration.
