# Service-Information Motorcycle

Group: 21  
Clutch

April 1989  
21 006 89  
(2355)

## Oil Leak at the Clutch Push Rod Boot - R & K Models

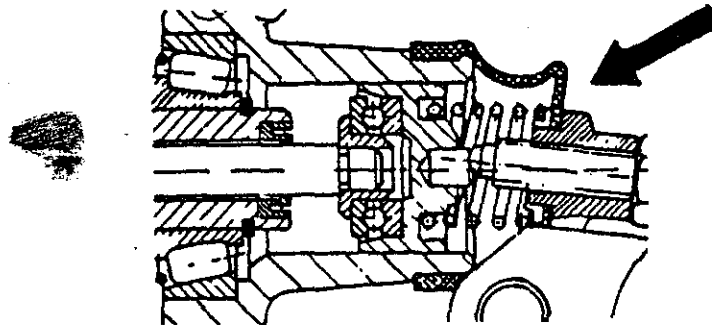
**Problem:** Gearbox oil leaking from the clutch push rod boot at the adjustment bolt.

**Cause:** Improper clutch adjustment. The coil spring cannot put enough pressure against the boot's sealing surface to contain the gear box oil when the clutch free-play is improperly adjusted. The greater the free-play, the further the sealing surface arcs back from the base of the spring.

**Remedy:** Adjust the clutch cable as described in the Rider's Manual or Workshop manual. It is extremely important to maintain the correct length of exposed cable at the gearbox clutch lever arm so that the coil spring under the push rod boot is at the proper tension.

**Note:** Most leaking boots can be corrected by cleaning the boot and seal surface, then re-installing and properly adjusting cable free-play.

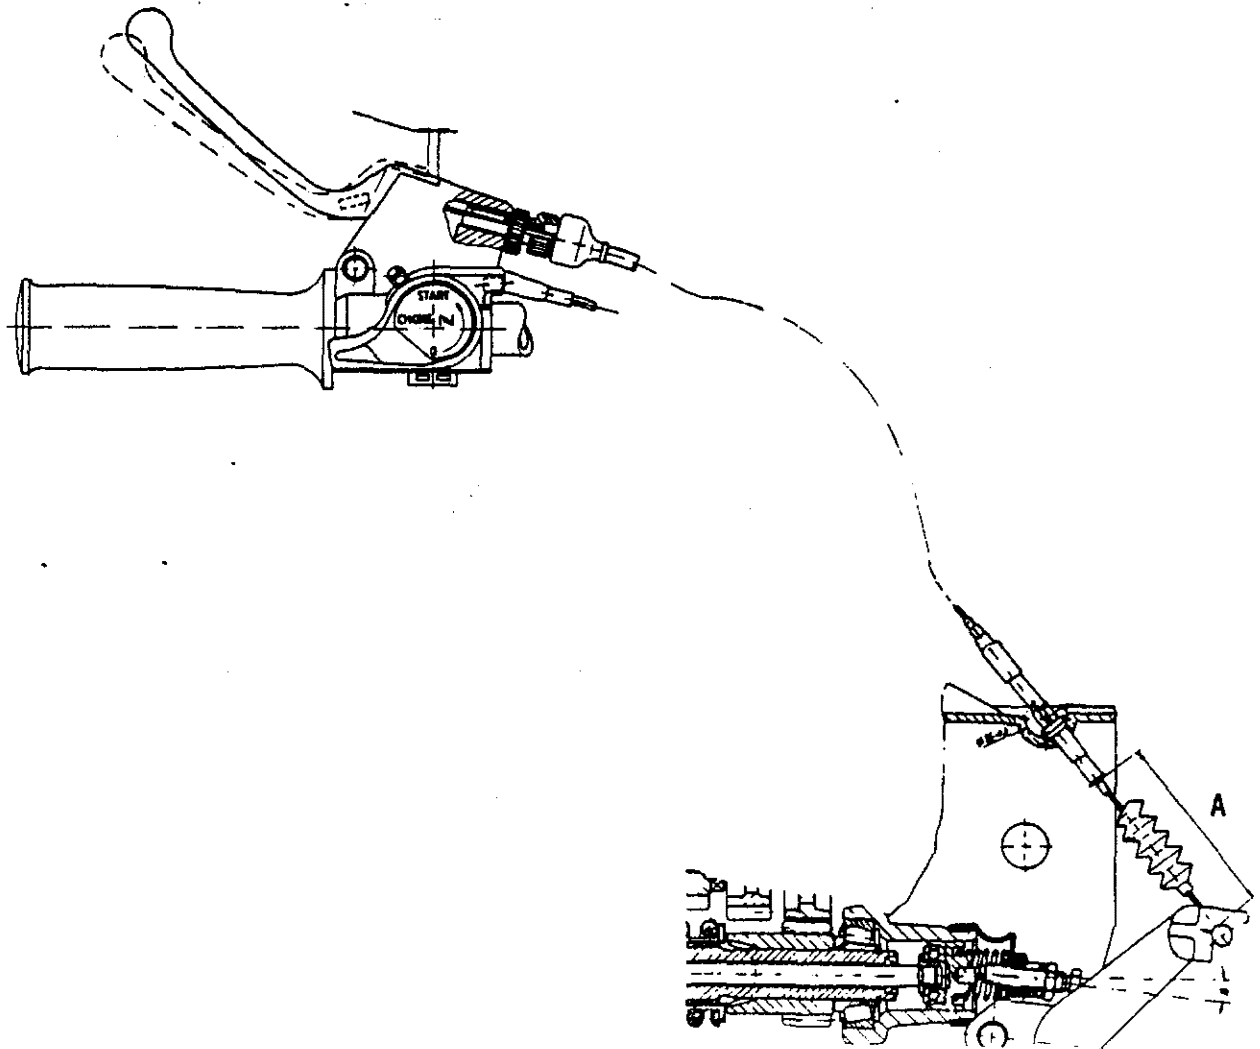
Correct length of exposed cable: ("A" on dwg)

K Models	75 ± 1 mm
R Models	201 ± 2 mm
