Service-Information

Group: 11 Engine	November 1982	Bulletin No.: 11 019 81 (2031)
---------------------	------------------	-----------------------------------

RE: ENGINE MODIFICATIONS

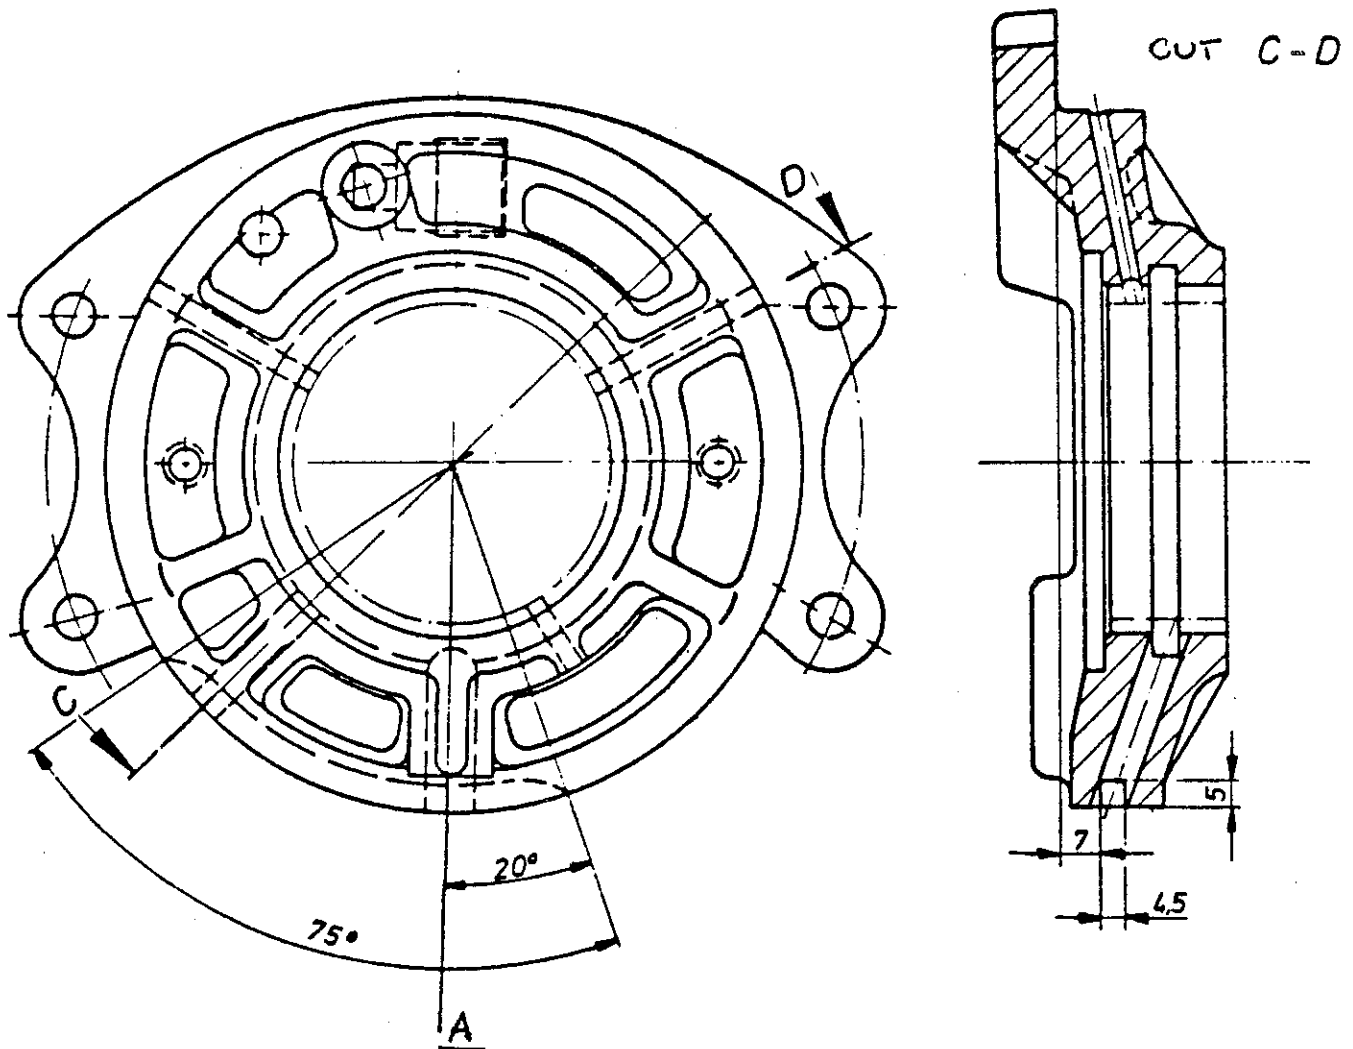
When an "Alcan" crankcase is used as a replacement on models which utilize a duplex (double row) timing chain camshaft drive (models 1970 to 1978), you must do one of two things:

If the above-mentioned modification or exchange is not done, no oil pressure will be obtained.

- (1) replace the front main bearing holder with a new design, part No. 11 11 1 259 593,
- (2) modify the existing main bearing holder to provide an oil distribution passage on the outer edge.

If you choose to modify the main bearing holder rather than replace it, use drawing below:
