SERVICE INFORMATION

Motorcycles R50/5, R60/5, R75/5
Group: engine

München, Jan. 71
No. 2/71 (303) eng

Ref.: Engine ventilation

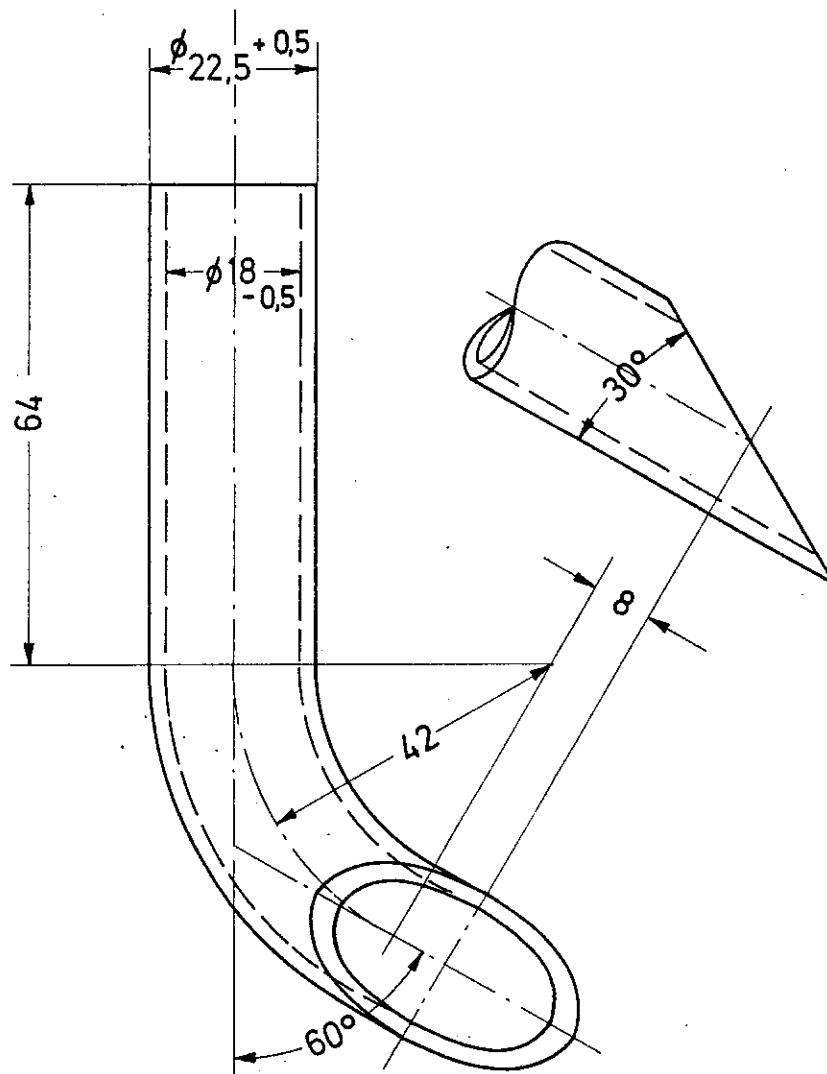
Service Information
Nr. 2/71 (303)

in order to avoid - as it happened in some cases - the contamination by oil condensate of the Micronic air filter inserts, a new ventilation hose, ordering No. 11 15 1 255 146, started in the series with chassis No.

Abnormal smoke of the right cylinder at idle speed - especially at cold engine - is caused by wrong cut slope or incorrect mounting of the vent hose.

1. Control cut slope of the new vent hose (see chart); if necessary re-work.
2. Dismount suction line and left half of air filter housing, loosen hose clip at old vent hose.
3. Unscrew right half of air filter and draw it off with vent hose.
4. Insert new vent hose into right half of air filter housing so that even end is standing over by approx. 36 mm over surface and that hose curve is in the center of suction line.
