# Service-Information Motorcycle

Fuel Tank  
and Lines

16 016 91  
(2486)

## Fuel Cap - All Boxer Models

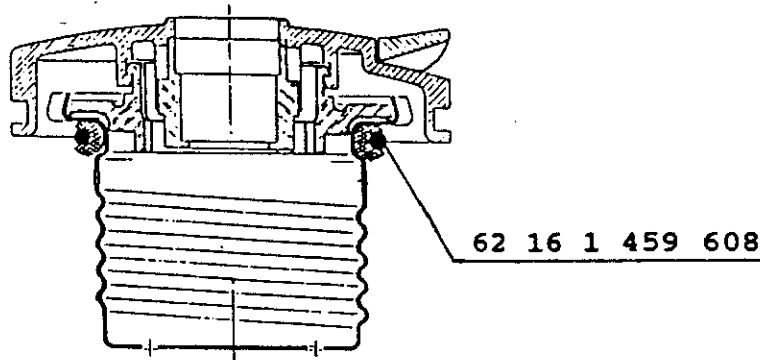
**Condition:** The fuel cap chafes the painted surface of the tank at the filler neck.

**Cause:** The filler neck is welded too deeply into the fuel tank.

**Remedy:** Install an O-ring - part no. 62 16 1 459 608 - into the groove of the fuel cap seal. The O-ring makes the seal slightly thicker and the cap cannot be screwed in as far.

Please check new motorcycles for appropriate fuel cap fit.

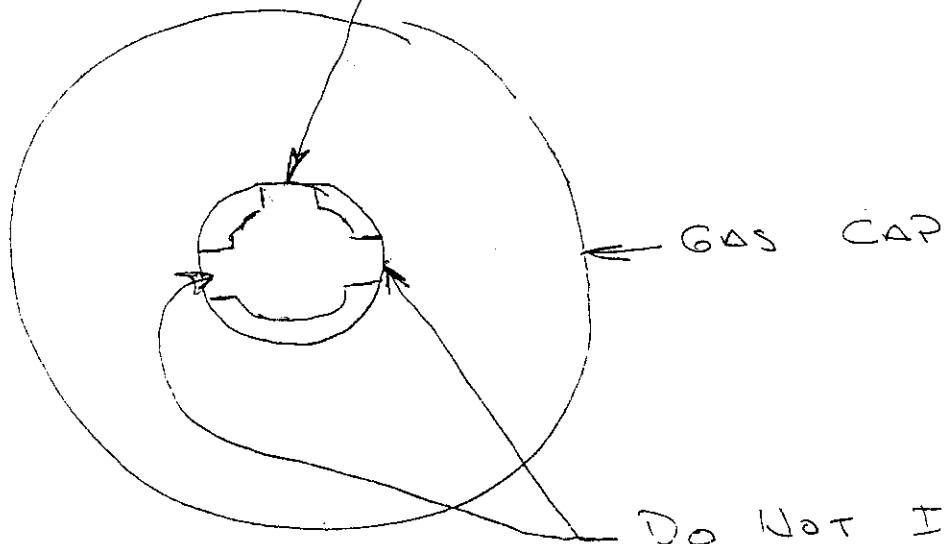
LOCKING TANG OF LOCK  
MUST GO IN ON THIS RAMP

DO NOT INSERT  
LOCK DOWN THESE  
SIDE PIECES WITH  
THIN RIBS AT BOTTOM
