BUTLER & SMITH, INC.

Re: Gas Tank Filler Cap Venting

R60/7	From	VIN 6 100 001	to	6 100 407
R75/7	From	VIN 6 120 001	to	6 121 470
R100/7	From	VIN 6 140 001	to	6 142 340
R100S	From	VIN 6 160 001	to	6 161 323
R100RS	From	VIN 6 180 001	to	6 181 262

/7 MODEL - FILLER CAP

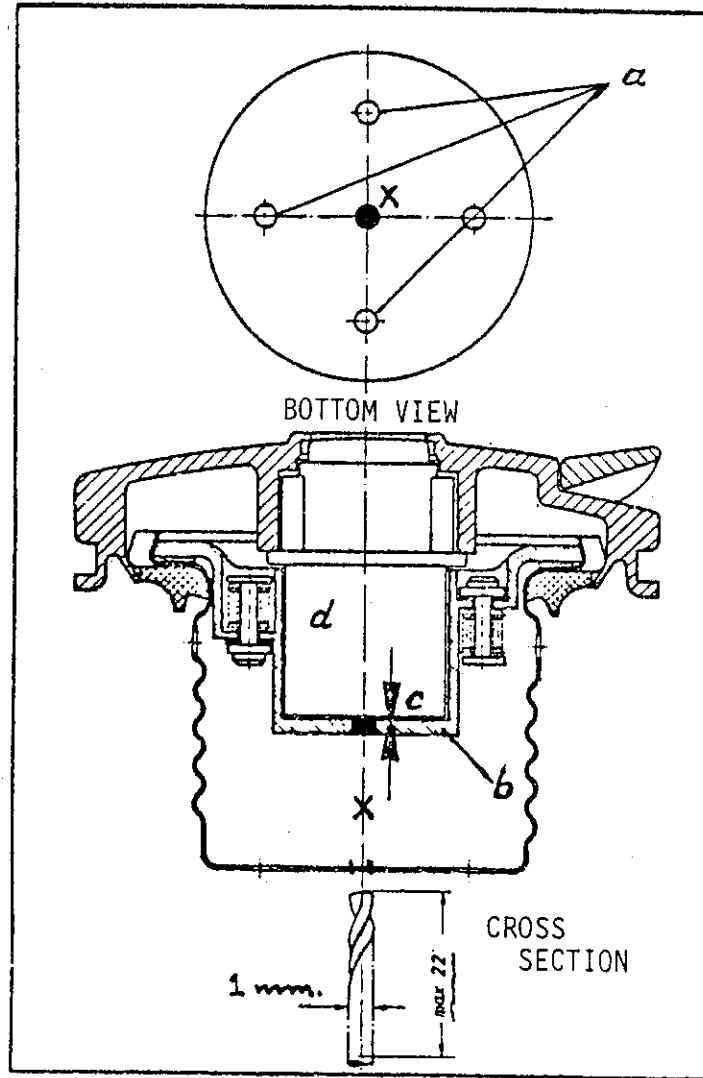
The vehicles affected were delivered with filler caps which have pressure relief valves incorporated. These valves could allow pressure build-up in the gas tank, which overrides the closing pressure of the float valve in the carburetor causing overflowing.

This gas overflow could result in a fire hazard. A modification of the gas cap is therefore required to prevent any pressure build-up in the gas tank.

CAUTION: Drill the sheet metal part first. You will then feel approximately 18mm of air space, then, hit the nylon valve casing (b), which is very soft, and then approximately at 21 to 22mm, you will feel that the drill will break through this first casing. Stop drilling immediately. In studying the enclosed drawing, you will see that the air gap (c) between the valve casing and the lock cylinder is very, very small.

The procedure for drilling a vent hole in the present /7 gas cap is as follows. Please study the enclosed drawing first.

1. Turning the gas cap upside down, the four holes (a) will be exposed and facing upward.
2. In order to find correct dead center, scribe two lines through a pair of corresponding holes. Slightly center punch the point where the two lines meet.
3. Using the chuck of the drill as a depth gauge, secure a 1mm (1/32") drill bit in its correct exposed length, so the free length will not exceed 22mm depth maximum.
4. Coat the drill flutes with a thick grease.

5. Upon completion of Step #4, drill a 1mm (1/32") hole at the exact center which you located in Step #2, or as indicated (x) in the drawing.

6. WARNING: In order to prevent the gas cap from being destroyed do not drill into the lock cylinder (d) or beyond the breakthrough point of the drill, through the valve casing.
7. Thoroughly clean the cap to ensure all drilling chips have been removed and then blow dry with compressed air.
8. The gas cap modification has been completed and the cap can be reinstalled.
