SERVICE BULLETIN 10-78-18 NS

## 1979 Ignition System

### Group 12 - Engine Electric

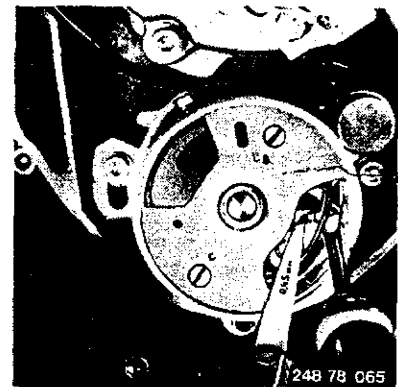
Check dwell angle ( $120^{\circ} \pm 3\%$ ) every 7500 km (5000 miles): disconnect the battery, remove the 3 Allen screws (5mm) and take off the generator cover. Remove contact breaker housing cover by loosening slotted head screw. Unscrew the spark plugs and turn the engine clockwise, looking from the front, by means of the Allen screw (6mm) holding the alternator rotor. Continue turning until the breaker arm lifts off fully. To replace burnt breaker points, dismount front bearing shield of breaker points camshaft. Before measuring dwell angle, mount it again. If no dwell angle meter is available, measure breaker points gap with a feeler gauge ( $0.45\text{mm} \pm 0.05\text{mm}$ ). To adjust the breaker points gap, loosen the set screw slightly, insert a screwdriver blade into the slot on the breaker plate and turn the screwdriver slightly until a gap of  $0.45\text{mm} \pm 0.05\text{mm}$ .

( $0.018 \text{ in} \pm 0.002 \text{ in}$ ) is obtained. Tighten the set screw and check that the gap has not altered. Fig. 1. Apply a small quantity of high temperature point cam grease on the point rubbing block every 15000 km (10000 miles), and check that the block is resting correctly on the cam.
