# Service-Information Motorcycle

Group: 62  
Instruments

March, 1988  
62 005 88  
(2295)

## Instrument Vibration - R Models

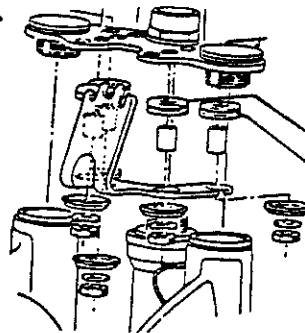
**Complaint:** Instrument vibration and Speedometer/Tachometer needles falling off.

**Note:** Pre-U.S. production R100RS motorcycles experienced this; all U.S. production motorcycles will have the updated mounts.

**Remedy:** The four (4) light-colored (Gray or White) rubber bushings, which the Instruments are mounted in, are now updated with **black** rubber bushings which are softer and therefore will absorb vibrations more effectively.

Part Nos.:  
31 42 1 232 244  
31 42 1 232 245  
(2 of each)

**Exchange:** During the course of servicing a European or Canadian R100RS motorcycle (early 1987 production), the light-colored rubber sleeves should be exchanged for the softer black sleeves.
