# Service-Information Motorcycle

Group: 52  
Dual Seat

August, 1988  
52 006 88  
(2321)

## Dual Seat Locating Arm - R100GS

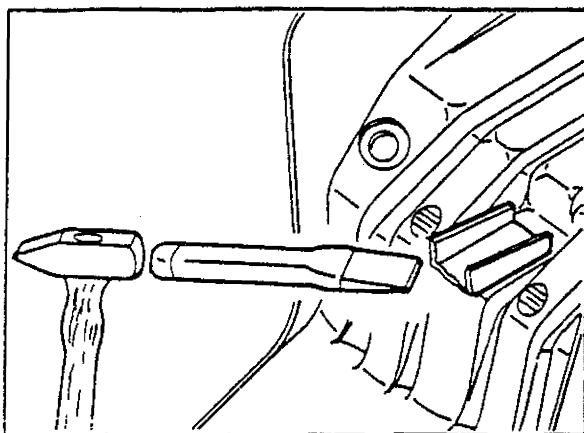
**Complaint:** Locating Arm breaks off

**Cause:** The method of attaching the Locating Arm (by hot glueing) causes the plastic arm to become brittle. If the seat is incorrectly installed (the plastic arm lying on top of the frame tube instead of into it), it can break under the rider's weight.

**Remedy:** Production motorcycles no longer have the glued-on arm. The arm is now bolted to the seat base. Remove the remaining part of the arm, using a chisel as shown below. Drill two 6.5mm holes in the seat base and install the parts contained in Repair Kit 52 53 2 307 170. See line drawing below for measurements:
