# Service-Information Motorcycle

Group: 31  
Front Forks

September, 1988  
31 023 88  
(2326)

## Noisy Upper Fork Spring Support - '85 R65, R80, R100 Models

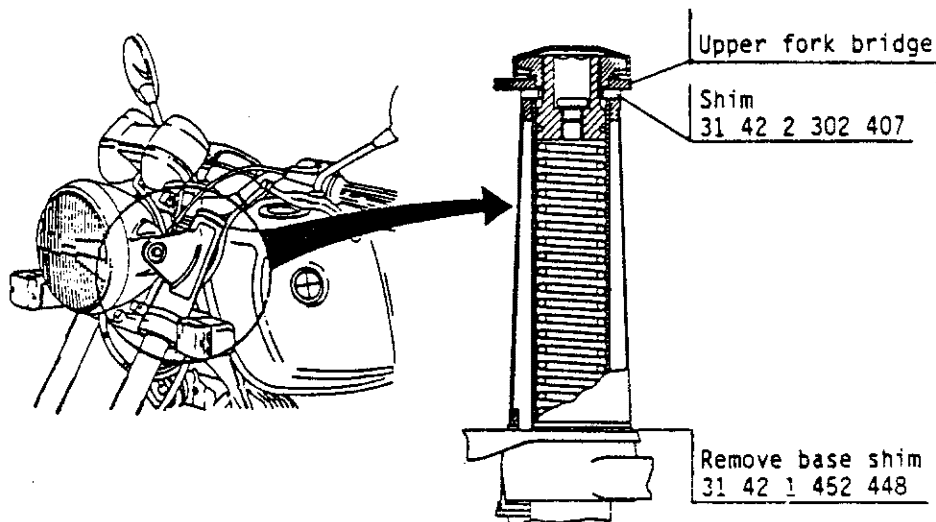
**Problem:** The fork spring support nut might work loose at the top fork bridge, causing an audible rattle.

**Cause:** The fork tube radius is pressing into the top fork bridge.

**Remedy:** Should this condition occur, install a shim:

Part no. 31 42 2 302 407

between the fork tube and top fork bridge to prevent the tubes from pressing into the casting.
