Service-Information

Group 11 Engine	May 1983	Bulletin No.: 11 024 83 (2077)
--------------------	-------------	-----------------------------------

RE: INSTALLATION OF THE OIL FILTER HOUSING CANISTER

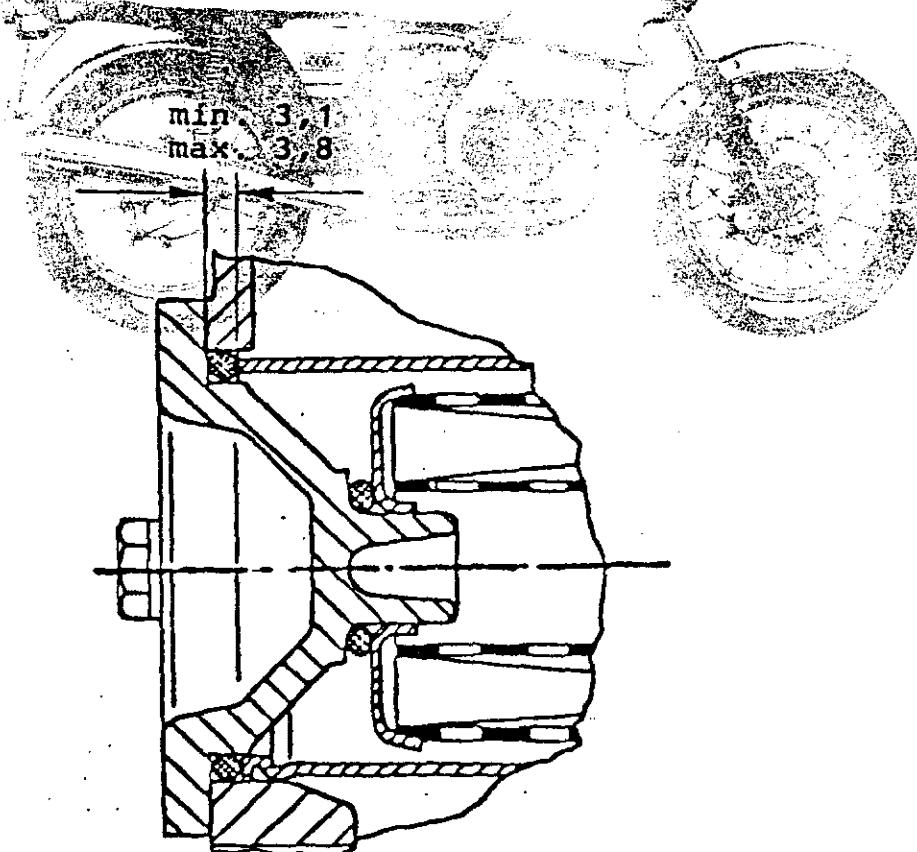
With the introduction of the R65 and change in the oil passages on all motorcycles beginning in 1980, it is possible in isolated cases that a small oil pressure drop can occur.

We suggest that during any service or rebuilds, the depth of the oil filter canister sleeve to crankcase cover be measured:

The distance between the oil filter cover surface and the face of the oil filter canister sleeve should be as referenced in the line drawing. Excessive clearance will cause a poor seal between the cover and canister sleeve and oil pressure will be reduced or fail.

Should the clearance be as described below, we suggest referring to Service Information 11 011 78 (1061R) for further details.
