SERVICE INFORMATION

Motorcycles R50/5, R60/5, R75/5
Group: Engine

München, Sept. 1970
n. 8/70 (289) en.

Subj.: Oil leakages around the chain case cover

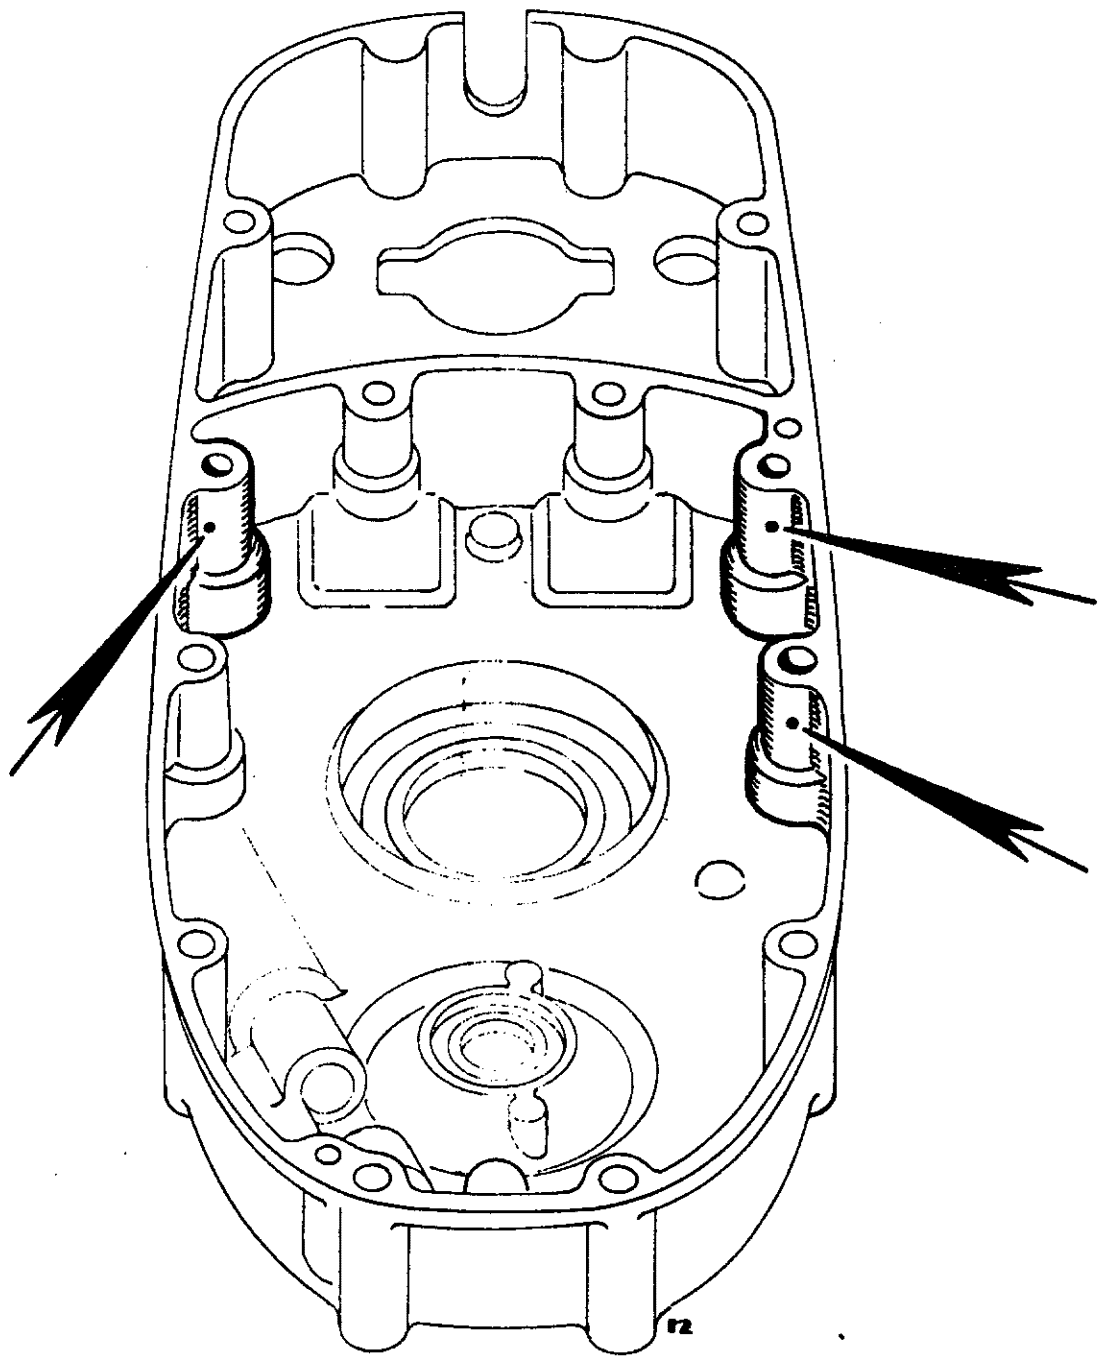
Service Information
Nr. 8/70 (289)

On a limited number of motorcycles the three studs to secure the chain case cover have been installed with Curil, instead of Loctite. Only on these machines it has been stated in several cases that oil leaks out, especially through the two upper holes of the studs.

To stop the trouble, remove the chain case cover (see workshop manual, pages 11-14/1) and, operating from below, apply a 2 mm hole into each through hole of the studs inside of the chain case cover (see figure).

By means of this measure, the oil pressure lasting on the through holes will be diverted into the interior of the housing.
