Service-Information

BMW MOTORRAD GMBH Techn.Kundendienst R-VK-11 ma/ur	Motorcycles R80/7-R100RS Technic Group: Engine	Munich, June 78 11 007 78 (1047R)
--	--	--

Subject: Piston and Wrist Pin Changes

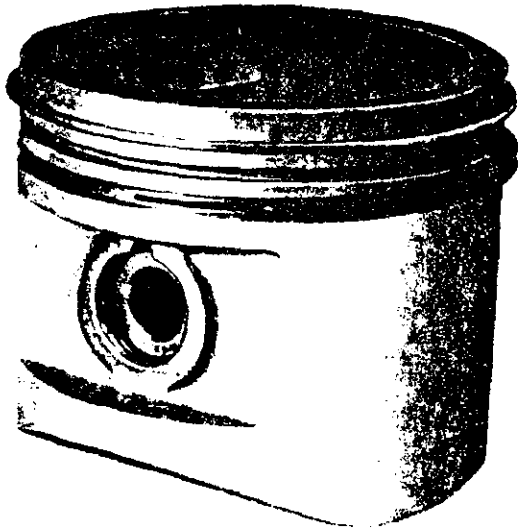
Present Type
(internal)

and all R 80/7 since the introduction of this model. The piston design was improved, the circlips are now secured to the wrist pin (external) instead of the inside of the piston (see attached pictures). The dome shape was changed in order to avoid excessive carbon build-up with a better flow pattern.

Due to the slight increase in weight, pistons with internal or external circlip location can not be installed singly but must match in both cylinders. Also when ordering watch for the (+) and (-) markings on the piston removed. Never mismatch the pistons; consider them as identical pairs.
