Service-Information Motorcycle

Group: 11
Engine

June 1986
11 034 86
(2214)

Oil Supply to the Rocker Shafts -- Boxer Engines

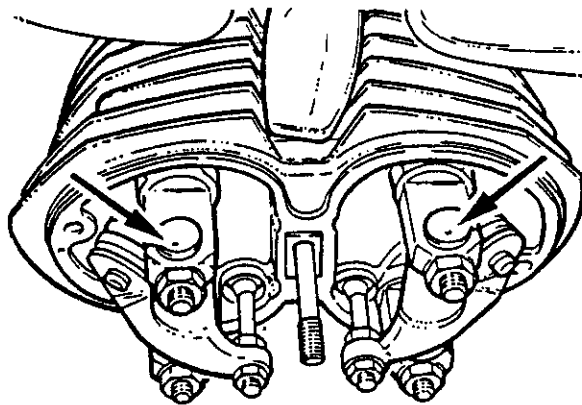
Examination of parts returned under warranty has revealed that the rocker shafts are sometimes installed incorrectly, so that the oil supply cannot reach the rocker pivot bearings.

The rocker shafts have an off-center punch mark on one end. Make sure that this mark is at the TOP on all shafts, and is FACING OUT, away from the cylinder head.

This is to insure that oil under pressure can reach the needle bearings by way of the upper studs and the bore in the rocker shafts. Installation as described will assure that the needle bearing is properly lubricated.

During service work, please look for the marks and insure they are in the proper location.
