# Service-Information

BMW MOTORRAD GmbH Service RM-K-11 fa	Motorcycle Technical Group: Dual Seat	Munich, July 79  52 001 79 (1069R)
--	---	--

Subject: Interference of Dual Seat with Gas Tank

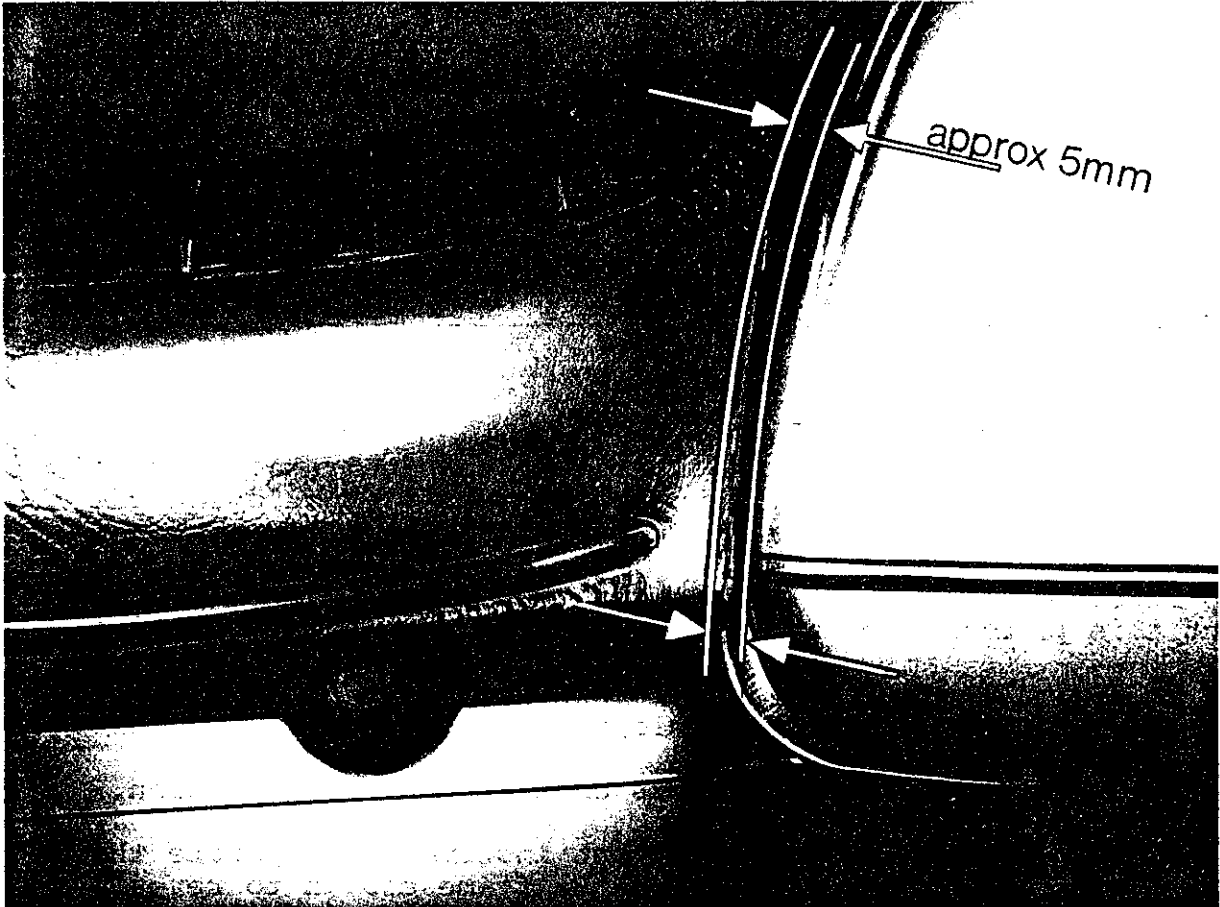
In isolated cases, it is possible that the dual seat front edge rubs against the gas tank damaging the paint or allowing the seat cover to be torn, as per enclosed picture.

Please note that the correct lines of the front nose of the seat is an equal gap along the contour of the gas tank.

We recommend that upon receipt of a new motorcycle, to check out this problem, and modify as follows:

- 1.) After you have determined where and by how much the alteration should take place, remove the seat.
- 2.) Remove the pop rivets on the front nose section.
- 3.) With the help of a blunt instrument, separate the seat cover from the metal frame enough to reveal the nose or front of the seat frame section to be reworked.
- 4.) Remove the determined amount of metal.
- 5.) Round off all sharp edges; cover the edges with tape to protect the seat cover for re-installation.

The foam rubber does not have to be cut or altered.

- 6.) The seat cover can now be re-glued to the metal frame by using an appropriate glue.
- 7.) Replace the pop rivets.
- 8.) Re-install dual seat and check clearances again.
