# Service-Information

BMW MOTORRAD GMBH Techn. Kundendienst R-VK-11 ma/ur	Motorcycles R90/6 - R90S Group: Engine	Munich, June 1978 11 006 78 (1045R)
---	---	--

Subject: Cylinder Head Locating

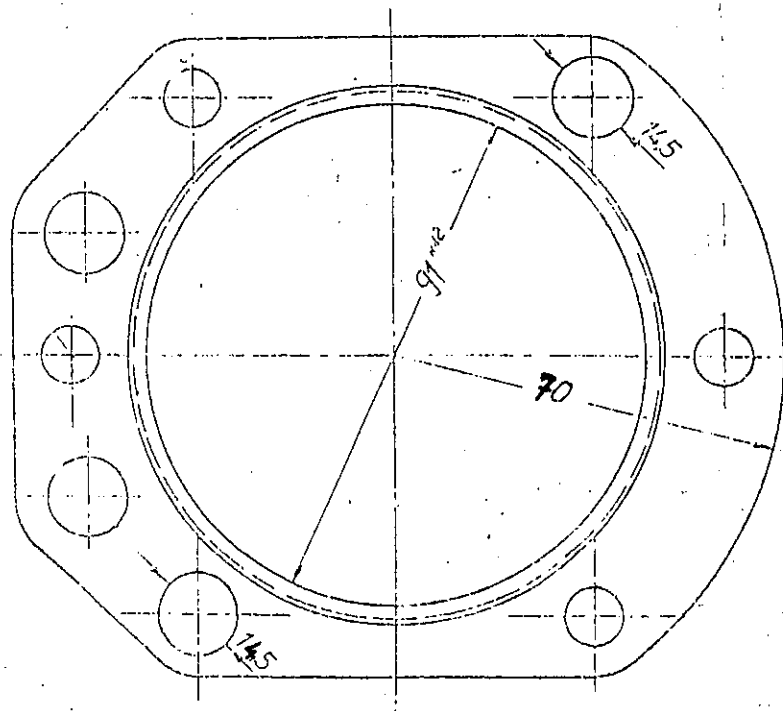
the countersink in the cylinder head and locating sleeve in the cylinder barrel

Part No. 11 11 1 258 311

are no longer manufactured.

At the same time, the head gasket corresponding holes were reduced to 10.5 - 11 mm diameter, all 6 holes are therefore identical.

The older head gasket, as per drawing, is no longer available.  
The new gasket

Part No. 11 12 1 261 672

could be used as follows:

Heat up the cylinder to remove the locating sleeves or enlarge the corresponding holes from 10.5 - 11 mm to 14.5 mm.

See above drawing.
