# Service-Information Motorcycle

January 1992  
33 017 92  
(2506)

## Rear Shock Adjustment Knob Numbering - R100GS 1991 Models

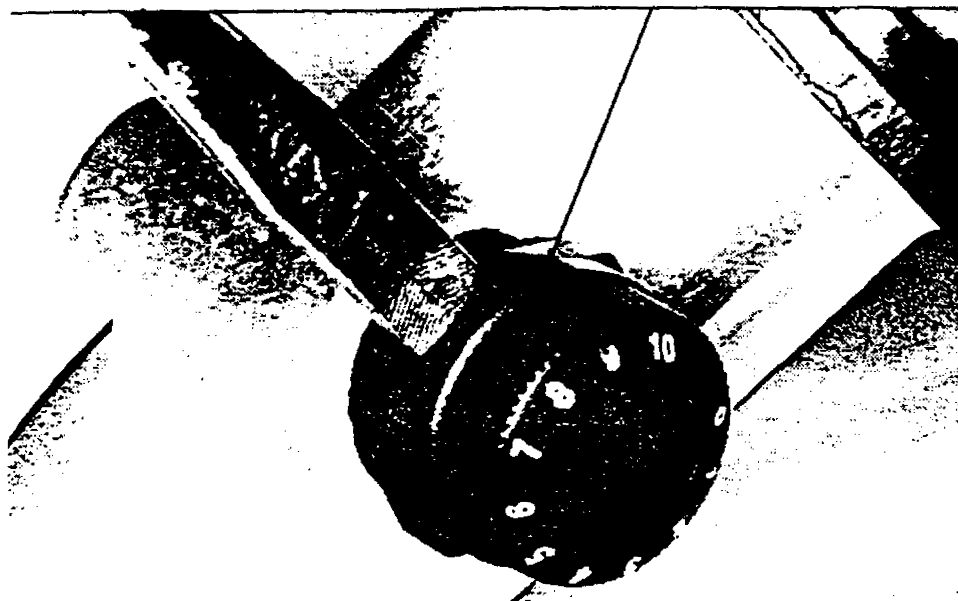
**Complaint:** The white numbers on the rear shock adjusting knob have a tendency to come off.

**Remedy:** Future adjusting knobs will have raised numbers. Replace the adjusting knob with:

Part No. 33 53 2 314 139

- Instructions:**
- Turn the knob to the maximum (position 10)
  - Using a center punch, put a mark on the plastic nut which is below the knob
  - Pry the knob off gently, using a screwdriver
  - Using a plastic hammer, drive the new adjusting knob on with the Figure 10 aligned with your center punch mark:
